April 5, 2001
HETA 2001-0090

On December 1, 2000, the National Institute for Occupational Safety and Health (NIOSH) received a request from management officials of Fun Country Marine Industries Inc. to evaluate carbon monoxide (CO) concentrations associated with the operation of houseboats on Lake Mead. On January 23 - 24, 2001, NIOSH investigators visited Lake Mead to investigate CO concentrations on houseboats located at Callville, Nevada. This letter describes our evaluation methods, findings, and conclusions.

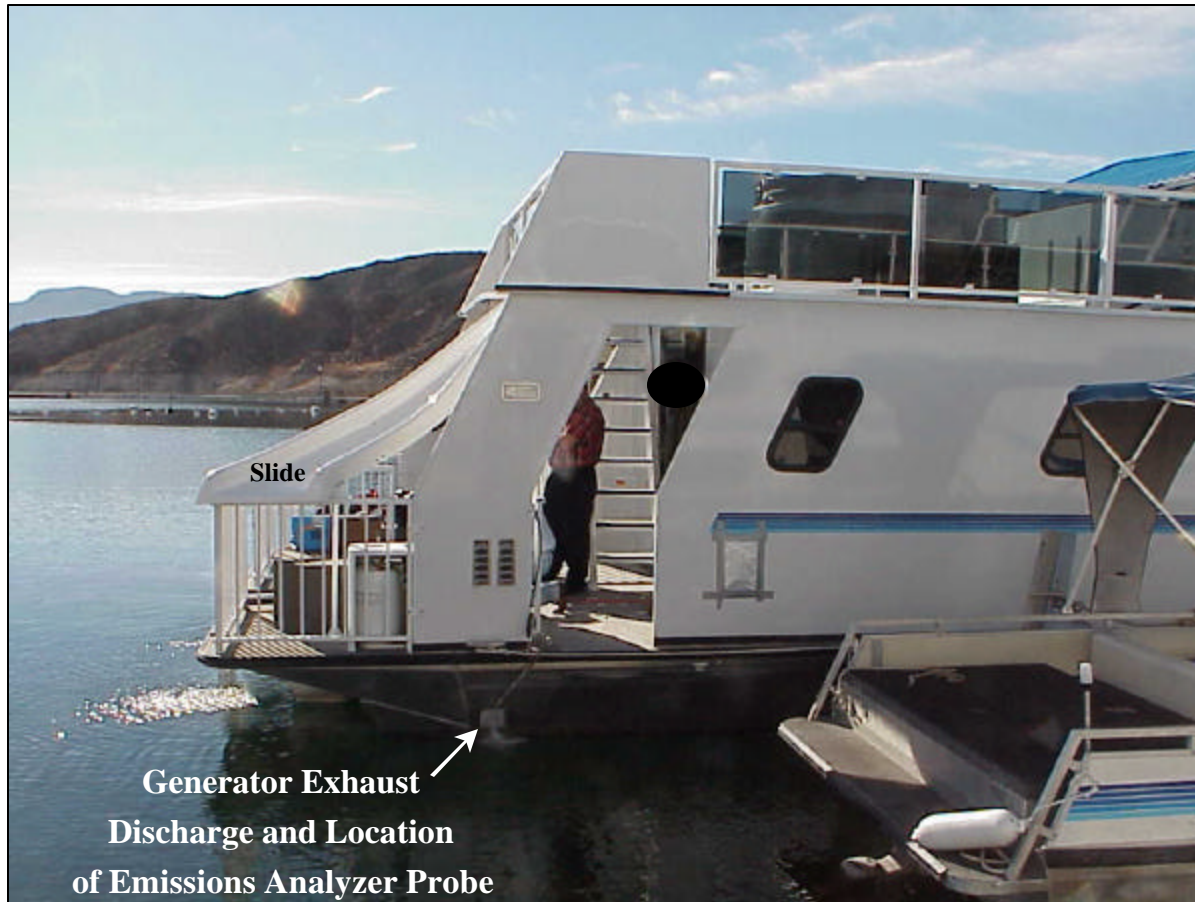
Figure 2 shows a portion of the back deck of the VIP houseboat, and illustrates the generator exhaust discharging out the side. Two evacuated glass container samples were collected in the area near the generator exhaust discharge. These two samples indicated CO concentrations of 3460 and 7071 ppm. Another evacuated container sample was collected directly off the back of the boat approximately 8 inches above the water. This sample indicated a CO concentration of 896 ppm.

Figure 2. Generator side exhaust on the 67' VIP houseboat at the dock.

During this survey, only one of the houseboats exhausted the generator to the side of the boat hull (see Figures 2 and 3). The area around the exhaust on the side of the boat indicated CO concentrations above the NIOSH IDLH value of 1,200 ppm⁴ when measured at the dock and in a cove on the lake. CO concentrations around the back deck (approximately 6-12 inches above the water where individuals could conceivably be swimming) indicated high CO concentrations (896 ppm) while the

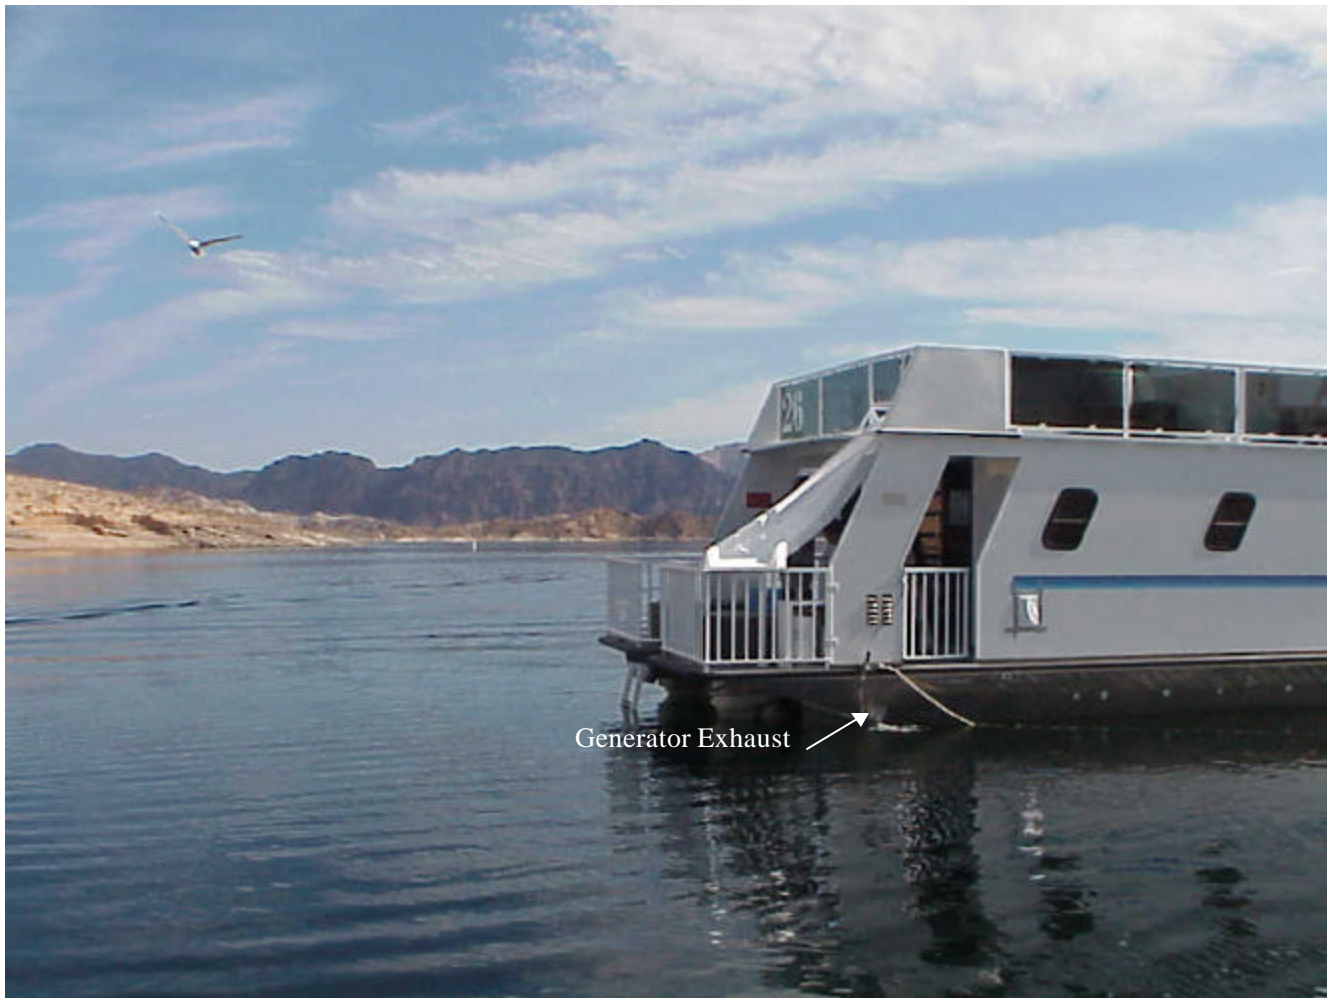
During the morning on January 24, 2001, the 67' VIP houseboat was placed out in a cove on the lake to evaluate CO concentrations (see Figure 3). This is the same houseboat that was evaluated at the dock on the first day of the evaluation. During this evaluation, the gasoline generator operated alone for approximately 60 minutes. Subsequently, the gasoline motors and generator were operated together for approximately 10 minutes. The 67' VIP houseboat had the following specifications.

Figure 3. Generator exhaust discharge on the 67' VIP Houseboat in a cove on the lake.

boat was at the dock, and while stationary in a cove on the lake, CO concentrations were measured above the NIOSH IDLH value. In the cove, high CO concentrations (>1000 ppm) were also measured on the floor of the back deck while the generator was in operation.
